Technical Report CERC-95-3
March 1995

Periodic Inspection of Cleveland Harbor East Breakwater, Ohio

Report 1 Base Conditions

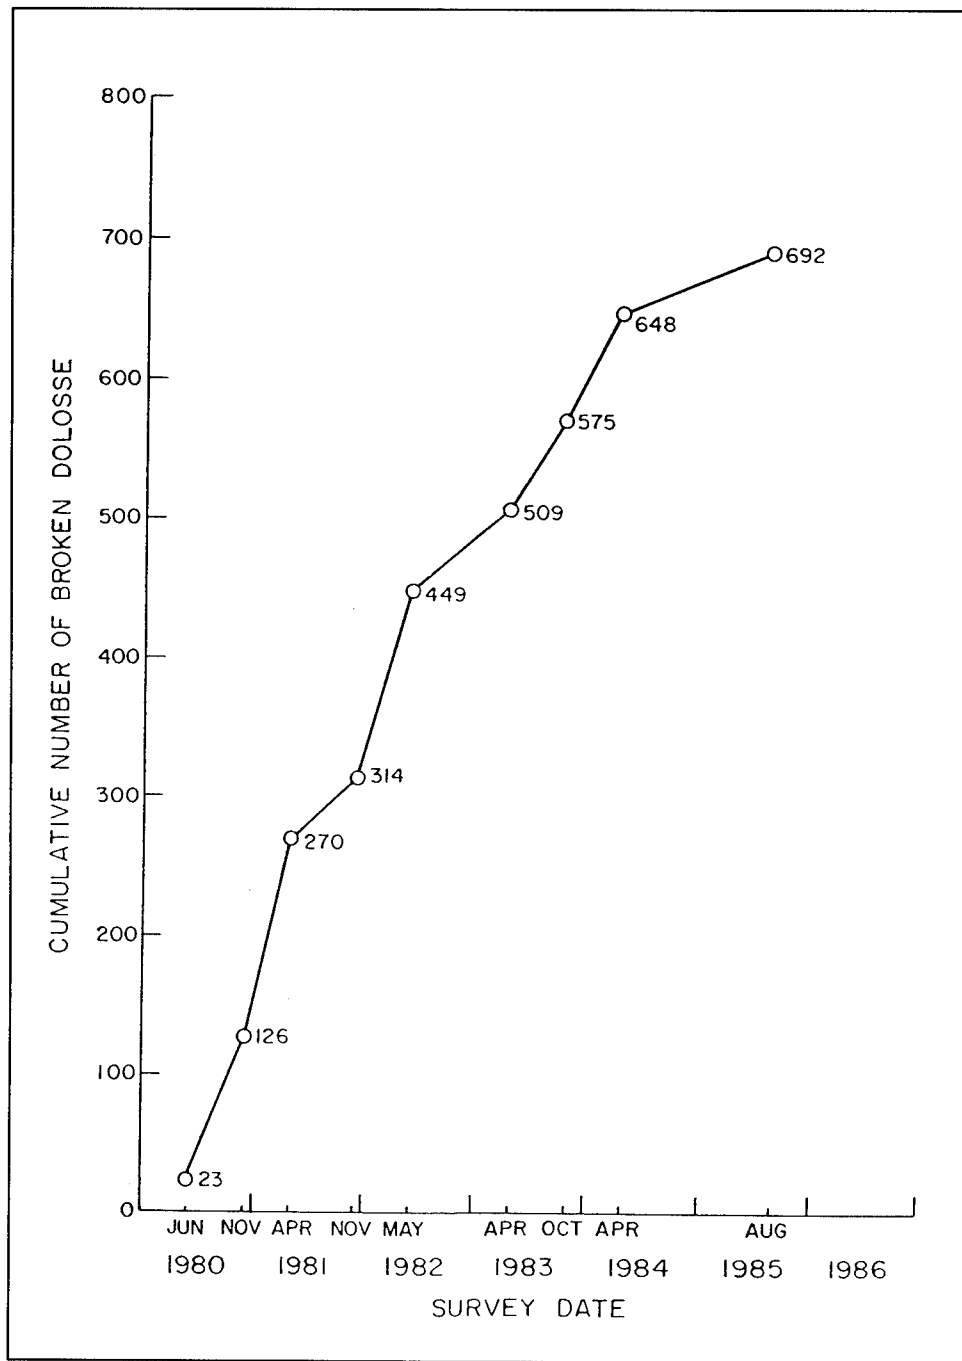
Evaluation of the broken dolos survey results from April 1980 to September 1985 indicated a total of 692 broken units above the waterline. The rate of new breakage appeared to have decreased slightly with time as shown by the cumulative number of broken units during the monitoring period (Figure 11). Approximately 30 percent of the dolosse were placed above the average annual mean lake level during construction. Therefore, about 8,972 dolosse of the total 29,741 were placed above the waterline within the primary wave impact zone. With 692 units broken, this yielded approximately an 8-percent breakage rate over the monitoring period ignoring below-water breakage.

Figure 11. Cumulative number of broken dolos during the monitoring period

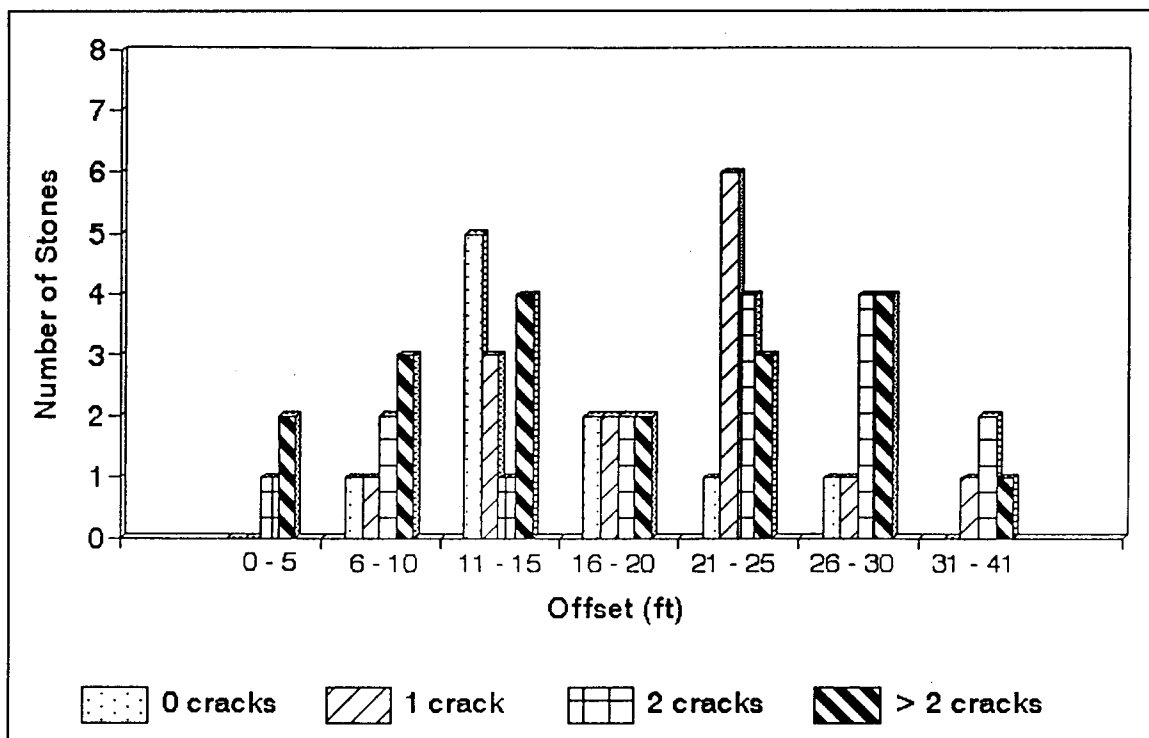
Study Reach 1 (sta 197+65-198+65) has been monitored annually throughout the project and is the best documented of the three study reaches. The Reach 1 evaluations reveal that of 59 stone armor units monitored between 1989 and 1992, random cracking is occurring across the entire profile of the breakwater reach (Figure 17). However, the relative frequency of the crack damage-type is largely skewed to the lakeside of the structure (Figure 18). Over the four years of monitoring, the worst damage classification, type "D," is occurring at or near the waterline. The number of significant cracks has increased with time on both damaged and undamaged stones. Of 12 good stones documented in 1989, two became significantly damaged by 1992; one cracking in each of the 6th and 7th years of exposure. The degree of damage change was highest between 1989 and 1990, likely due to increased storm frequency and duration compared with later years. The apparent mechanism for cracking is about half blast related and half natural. Of 93 cracks documented in study Reach 1, 49 were recorded as blast related (53 percent), and 44 cracks (47 percent) were apparently caused by natural consequences such as freeze-thaw, wet-dry, or other weathering factors. At the end of monitoring in 1992, 83 percent of the stones on study Reach 1 was documented as being cracked.

Figure 17. Cracked stone distribution along study Reach 1

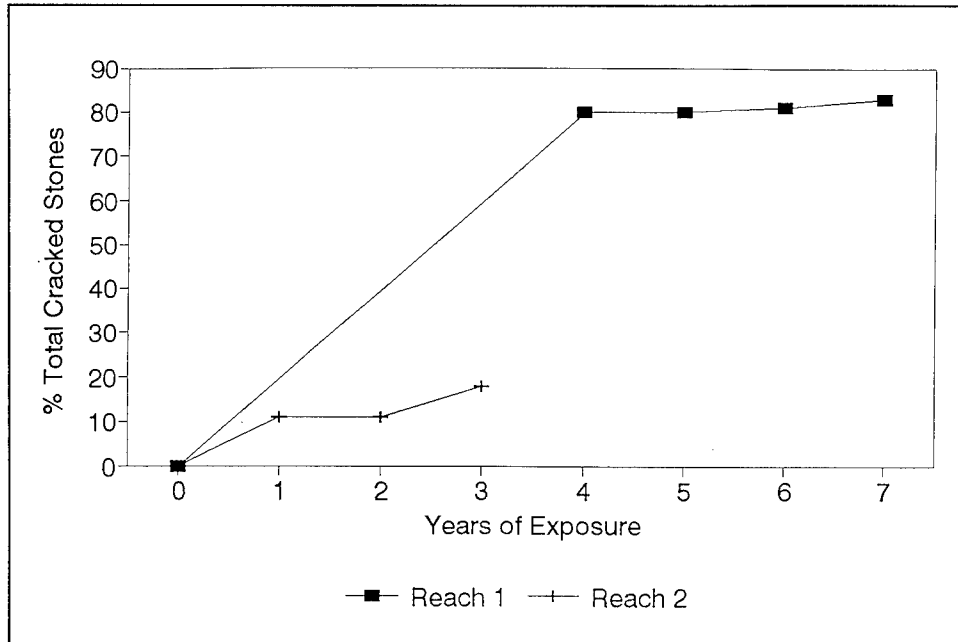
In 1990 (one year after construction), the enhanced QC/QA effort of study Reach 2 (sta 107+50-108+50) was initially deemed successful because less than 1 percent of the stones monitored revealed crack damage. At the quarry about one-half of the total stone stockpile had been rejected due to blast damage. This correlates closely with the 50 percent apparent blast crack damage recorded in study Reach 1. Evaluations two years after placement revealed 11 percent crack damaged stone on this study section and along additional portions of the rehabilitation. Similar to study Reach 1, cracking was observed randomly occurring throughout the structure. A small number of developing blast cracks were found and notes from the enhanced QC/QA program reveal that these damaged stones were often marginally passed. Three years of documentation on study Reach 2 indicated that the enhanced QC/QA operation has significantly reduced the amount of blast damaged stone placed on the structure; however, natural cracking is still occurring. Study Reach 2 had a significantly lower cracking rate after three years of exposure (18 percent) as compared with the 83 percent cracked stone damage on study Reach 1 after four years. In addition, only 10 percent of the cracked stones on study Reach 2 have multiple cracks as opposed to about 50 percent on study Reach 1. A comparison of the percentage of cracked stones versus years of exposure for study Reaches 1 and 2 is shown in Figure 19.

Figure 19. Cracked stones for study Reach 1 versus study Reach 2

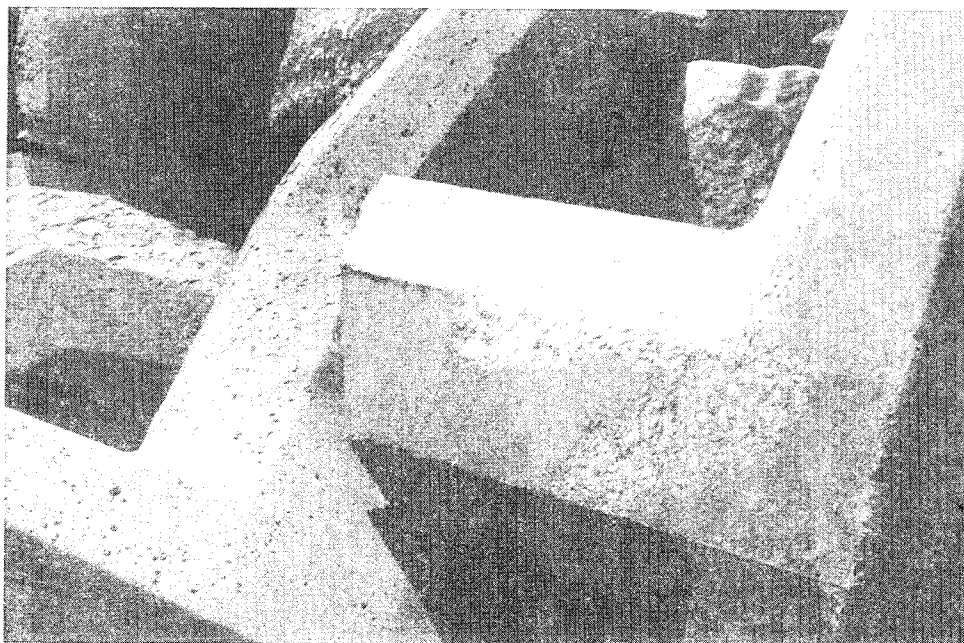
a. Angled mid-shank break

b. Straight mid-shank break

Figure 21. Dolosse with straight and angled mid-shank breaks

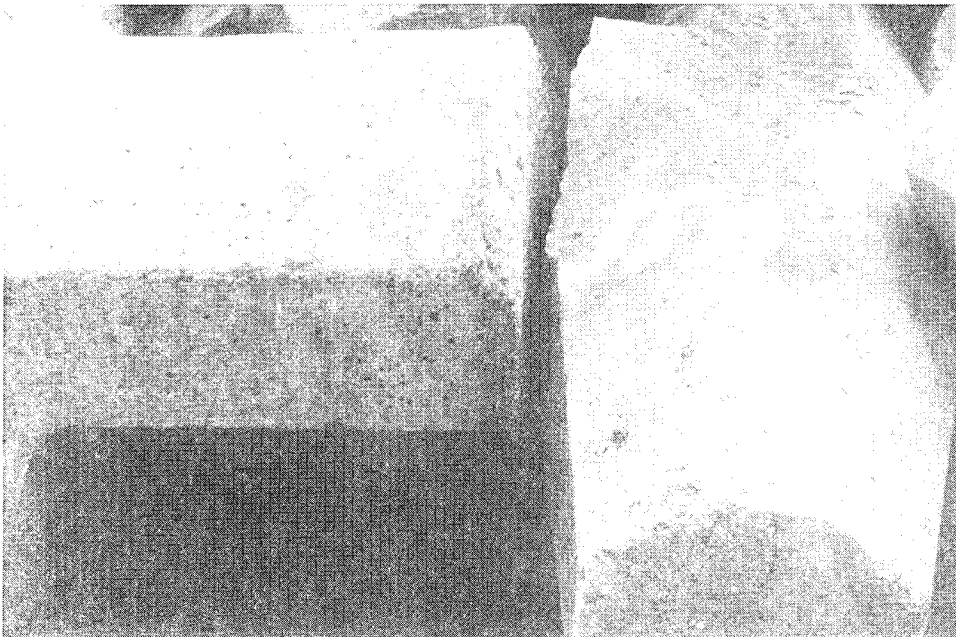
a. Angled shank-fluke break

b. Straight shank-fluke break

Figure 22. Dolosse with straight and angled shank-fluke breaks
